**Flood Control Project Maintenance
Levee Inspections**

Fall 2015 Levee Maintenance Deficiency Summary Report

Reclamation District No. 2095 Paradise Cut

Levee Inspection Report By Mile - Fall 2015

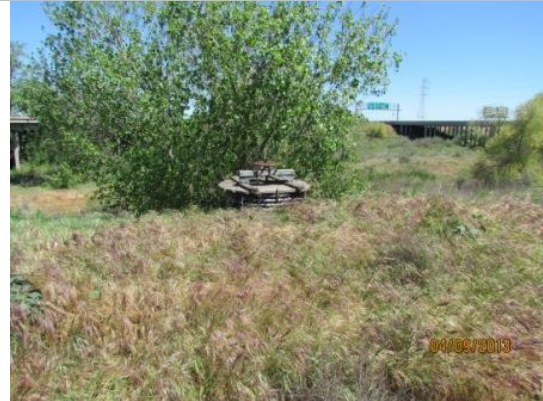
Photo 1 of 1 : FA_2015_RD2095_322_3_20150910_00002.jpg

View of the pipe at waterside levee hinge.

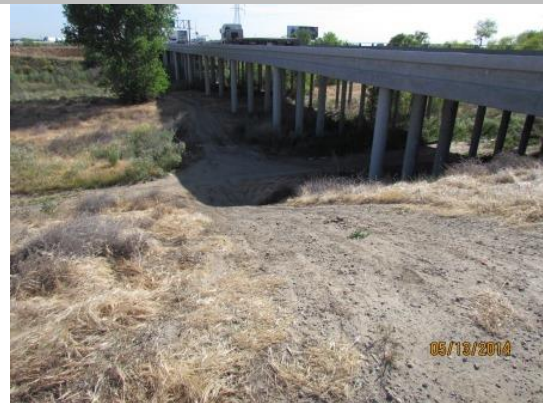
Photo 1 of 1 : FA_2015_RD2095_322_134_20150910_00008.jpg

LM Start	0.11	Rating **	A/W	Issue No.	134
LM End	0.11	Issue Type +	Ma	Location *	WS
Category	Earthen Levee			GPS Latitude/Longitude	
				Start	End
Item	Slope Stability			37.770212 °	37.770212 °
				-121.325675 °	-121.325675 °
DWR ID	DWR_RD2095_01_s_2014_134				
Action/Comments					
Repair the levee slope damaged by vehicle traffic and prevent access where possible.

View of the vehicle access on the waterside levee slope.

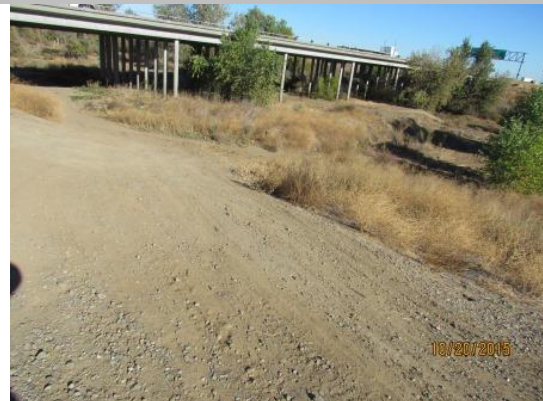
Photo 1 of 1 : FA_2015_RD2095_322_10_20151026_00014.jpg

LM Start	0.15	Rating **	A/W	Issue No.	10
LM End	0.15	Issue Type +	Ma	Location *	WS
Category	Earthen Levee			GPS Latitude/Longitude	
				Start	End
Item	Slope Stability			37.769997 °	37.769997 °
				-121.325055 °	-121.325055 °
DWR ID	DWR_RD2095_01_f_2015_10				
Action/Comments					
Repair the levee slope damaged by vehicle traffic and prevent access where possible.

View of the vehicle tracks on the waterside levee slope.

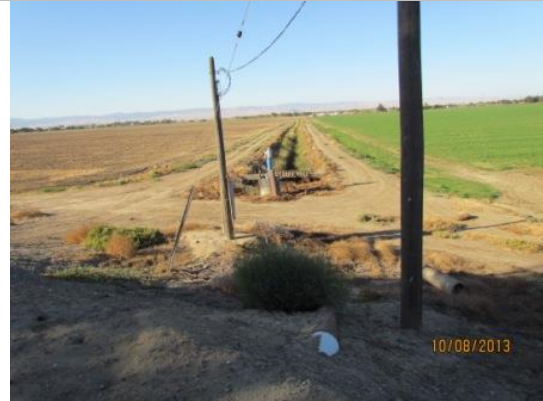
Photo 1 of 2 : FA_2015_RD2095_322_5_20150910_00004.jpg

View of pipe daylighting at landside levee slope.

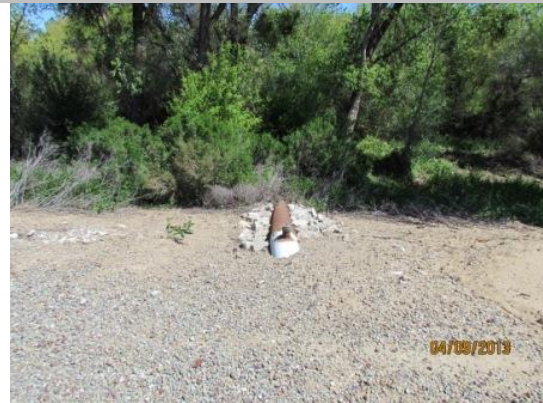
Photo 2 of 2 : FA_2015_RD2095_322_5_20150910_00005.jpg

View of the pipe penetrating waterside levee slope.

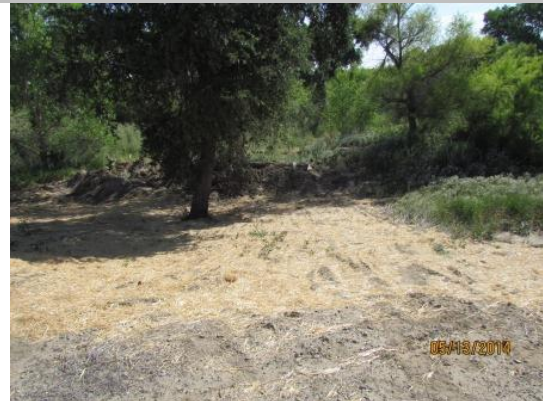
Photo 1 of 1 : FA_2015_RD2095_322_13_20150910_00007.jpg

LM Start	0.42	Rating **	A/W	Issue No.	13
LM End	0.42	Issue Type +	Ma	Location *	WS
Category	Earthen Levee			GPS Latitude/Longitude	
				Start	End
Item	Slope Stability			37.766917 °	37.766917 °
				-121.322267 °	-121.322267 °
DWR ID	DWR_RD2095_01_s_2013_13				
Action/Comments					
Repair the levee slope damaged by vehicle traffic and prevent access where possible.					
Inspector Comments: LMA is actively controlling the slope instability.

View of the repaired waterside levee slope.

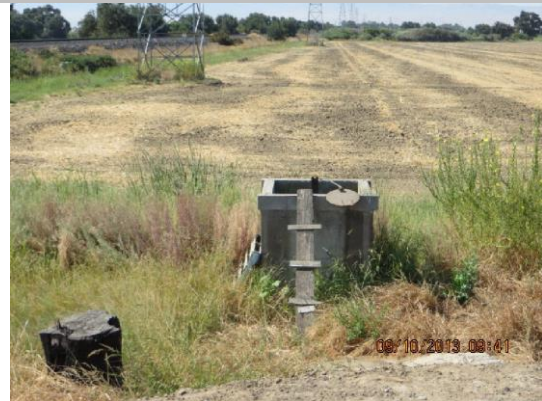
Photo 1 of 2 : UCIP_FA_2015_1677.jpg

LM Start	0.69	Rating **	M	Issue No.	243
LM End	0.69	Issue Type +	En	Location *	WS
Category	Supplemental			GPS Latitude/Longitude	
				Start	End
Item	DWR UCIP Field Study			37.763859 °	37.763859 °
				-121.319096 °	-121.319096 °
DWR ID					
Action/Comments					
Inspector Comments: FS_ID:19787 DS_ID:21635 EP_NO: N/A FS_HLM: 0.698 Repair Type: Non-Urgent Crossing Status: Found UCIP Comments: Wooden walkway to pier possible safety hazard as wood planks are rotten. Positive closure device missing from distribution box on LS toe. FIELD_STRUCT_DESC: 16-inch steel irrigation pipe through the levee 8.0 feet below the crown. Pump on pile structure in the channel. 5'X5' concrete distribution box at the toe of the landward slope. Originally included in the 1964 O&M manual. FS Date: 09/10/2013

Concrete distribution box on LS toe.

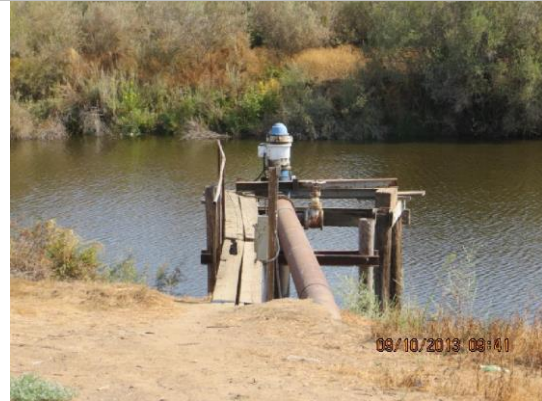
Photo 2 of 2 : UCIP_FA_2015_1678.jpg

Pump on pier on WS toe.

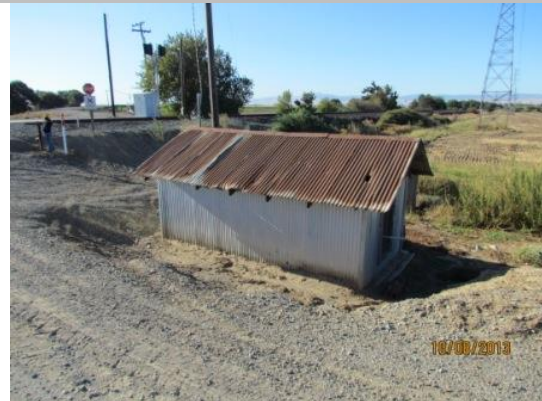
Photo 1 of 1 : FA_2015_RD2095_322_11_20150910_00006.jpg

LM Start	0.71	Rating **	M	Issue No.	11
LM End	0.71	Issue Type +	En	Location *	LS
Category	Earthen Levee			GPS Latitude/Longitude	
				Start	End
Item	Encroachments			37.763630 °	37.763630 °
				-121.319045 °	-121.319045 °
DWR ID	DWR_RD2095_01_s_2012_11				
Action/Comments					
Building Inspector Comments: Pump house near RR.

View of building at the landside levee toe.

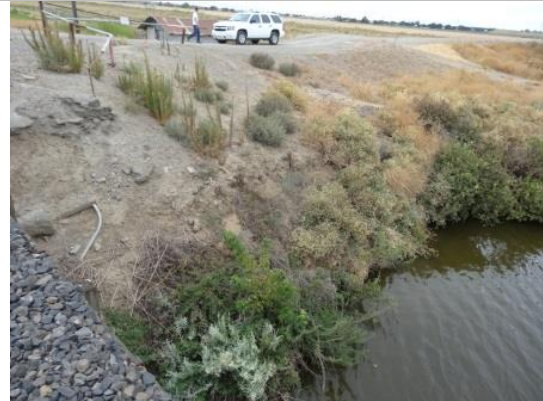
Photo 1 of 2 : SJR2015_RD2095U01RM6.74_14.jpg

Inspector Comments: 08/04/2015: No significant change observed.
 08/26/2014: No significant change observed.
 08/28/2013: No significant change observed.
 07/18/2012: No significant change observed.
 09/02/2011: No significant change observed.
 09/22/2010: No significant change observed. There is now considerable vegetation at the water line and along the lower berm slope. However, the erosion on the lower berm slope is still present and has not been corrected.
 08/06/2010: Recommended for local maintenance issue, per CLRO.
 07/29/2009: No major change since last visit; noticeable vegetation growth; erosion is on berm, but if left untreated, it will eventually erode into levee prism; site is recommended for annual assessment and monitoring of the site, per CLRO CES 2008 Report; Site # is the same as RM6.80, LM0.73; previously rated "U".
 07/22/2008: Downstream of WPRR near siphon pipe & pump; sandy levee; visited by Jeff Van Gilder and LRO in 2008 for repair assessment; scouring downstream of RR crossing, possibly caused by eddy effects.

Close view of the erosion downstream of the RR bridge.

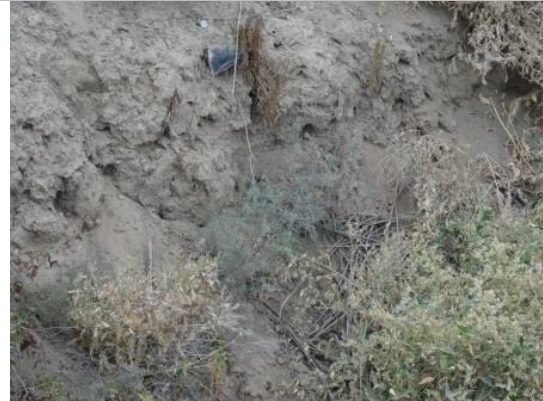
Photo 2 of 2 : SJR2015_RD2095U01RM6.74_9.jpg

Close view of the erosion.

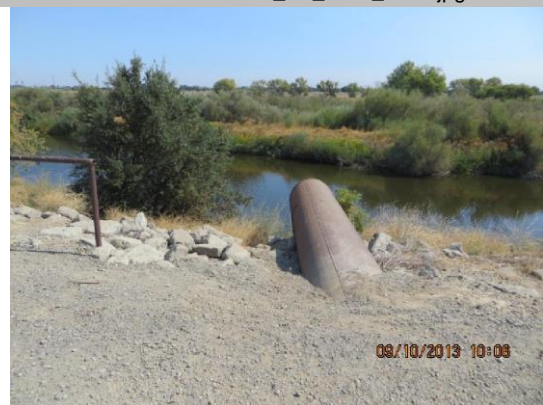
Photo 1 of 3 : UCIP_FA_2015_1679.jpg

Pipe on WS shoulder.

Inspector Comments: FS_ID:19812
 DS_ID:21637
 EP_NO: 13926
 FS_HLM: 0.874
 Repair Type: Non-Urgent
 Crossing Status: Found
 UCIP Comments: No electrical connection can be identified. Possibly awaiting a flood event for re-activation.
 FIELD_STRUCT_DESC: 40-inch steel stormdrain discharge pipe through the levee 1-foot below the crown. 6 pumps mounted on wooden pier at LS toe, all discharge into 40-inch pipe. Permit was for a 24-inch steel discharge pipe through levee 2.0 feet below crown with a flapgate on waterward side. But, Permit notes show it was modified in 2001 to its current status (Permit No. 13926).
 FS Date: 09/10/2013

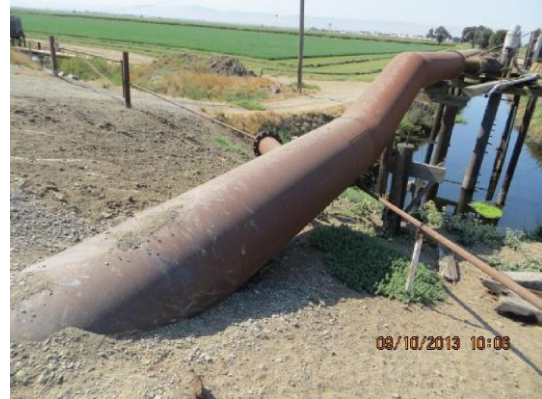
Photo 2 of 3 : UCIP_FA_2015_1680.jpg

Pipe on LS slope.

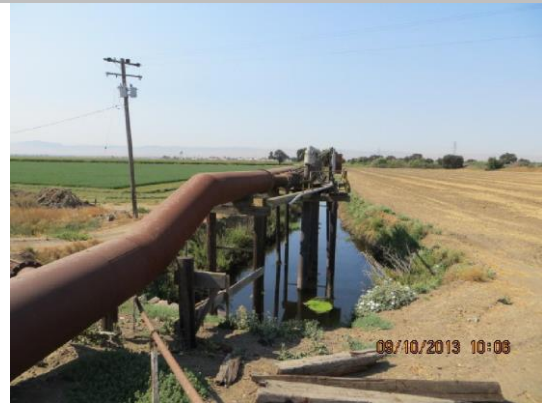
Photo 3 of 3 : UCIP_FA_2015_1681.jpg

Pumps on pier at LS toe. Note electrical conduit without connection on right side of pier.

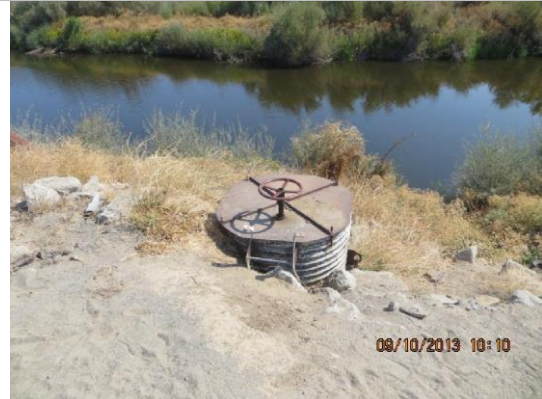
Photo 1 of 3 : UCIP_FA_2015_5738.jpg

Slide gate in 48-inch CMP riser on WS shoulder.

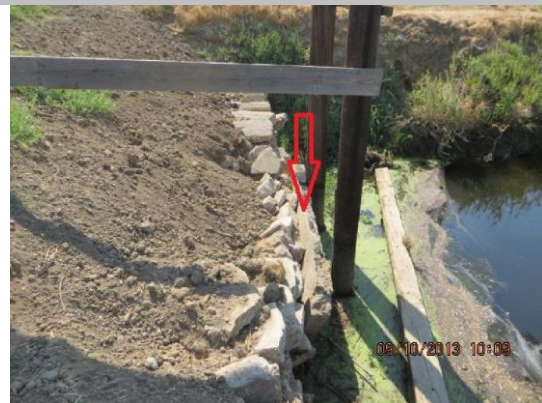
Photo 2 of 3 : UCIP_FA_2015_5739.jpg

Concrete headwall on LS toe is tilting heavily towards canal.

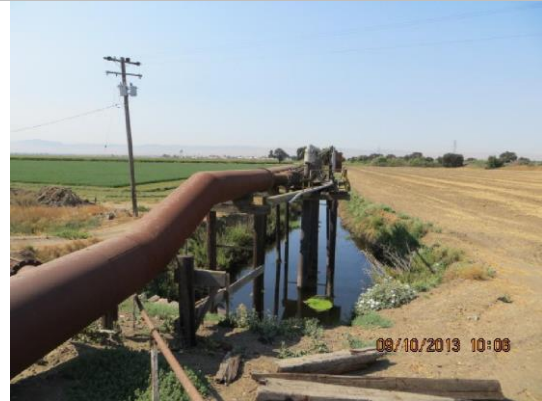
Photo 3 of 3 : UCIP_FA_2015_5740.jpg

Pipe inlet located below 40-inch pipe at LS toe canal.

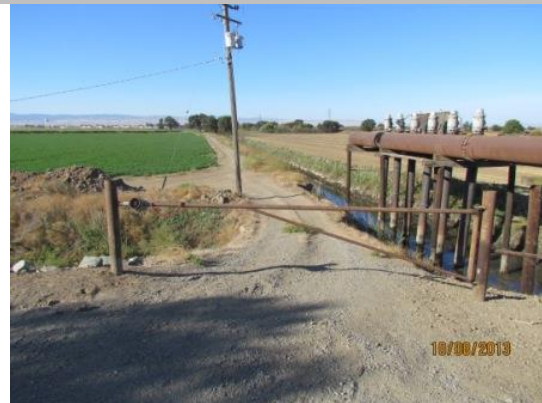
Photo 1 of 1 : FA_2015_RD2095_322_4_20150910_00003.jpg

LM Start	0.88	Rating **	A/W	Issue No.	4
LM End	0.88	Issue Type +	En	Location *	LS
Category	Earthen Levee			GPS Latitude/Longitude	
				Start	End
Item	Encroachments			37.761475 °	37.761475 °
				-121.317804 °	-121.317804 °
DWR ID	DWR_RD2095_01_f_2013_4				
Action/Comments					
Fence					
Inspector Comments: Permitted gate across landside levee ramp. A key was provided to the DWR inspector.

View of the new gate at landside levee hinge.

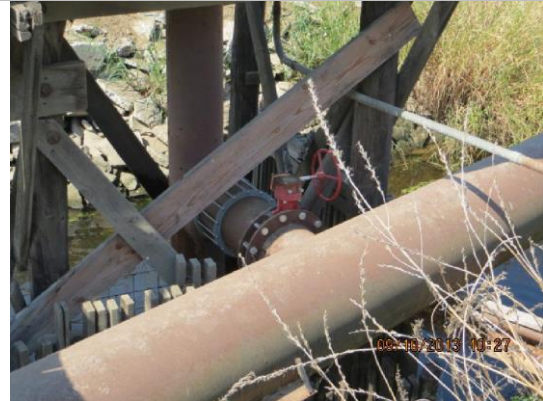
Photo 1 of 3 : UCIP_FA_2015_1685.jpg

Inspector Comments: FS_ID:19815
 DS_ID:21630
 EP_NO: N/A
 FS_HLM: 0.913
 Repair Type: Non-Urgent
 Crossing Status: Indicator Found
 UCIP Comments: Pipe abandoned and should be verified as having been done so properly.
 FIELD_STRUCT_DESC: 12-inch steel stormdrain pipe through the levee 1.5 feet below the crown. Pump on pile structure in drain ditch on landward side. Siphon breaker in steel standpipe on the waterward slope. Originally included in the 1964 O&M manual.
 FS Date: 09/10/2013

Possible location of 12-inch pipe connection to pump on LS toe.

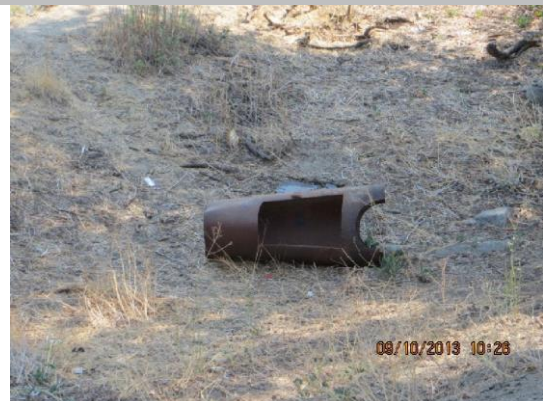
Photo 2 of 3 : UCIP_FA_2015_1686.jpg

Standpipe discarded on WS berm.

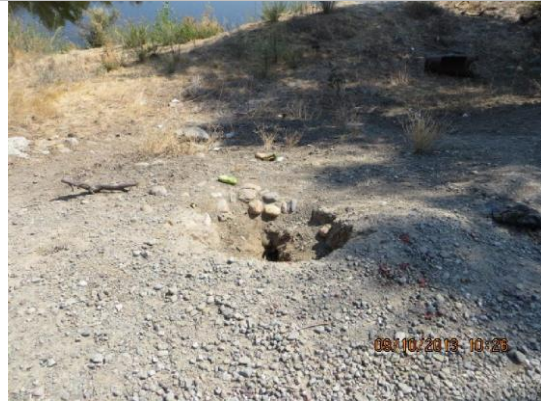
Photo 3 of 3 : UCIP_FA_2015_1687.jpg

Hole on LS shoulder where standpipe may have been located.

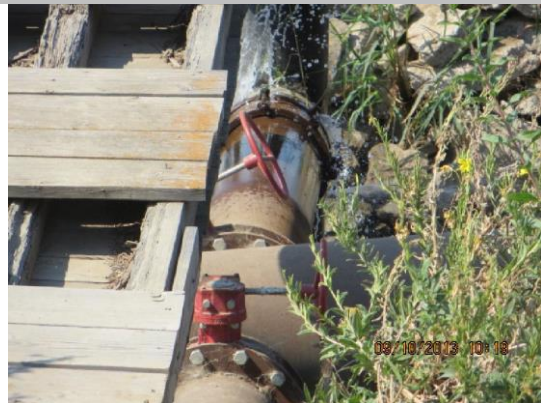
Photo 1 of 3 : UCIP_FA_2015_1682.jpg

Butterfly valve at pump on LS toe.

Inspector Comments: FS_ID:19813
 DS_ID:21631
 EP_NO: 6537
 FS_HLM: 0.915
 Repair Type: Non-Urgent
 Crossing Status: Found
 UCIP Comments: Corroded holes on pipe at outlet WS toe, good indication of internal pipe condition. Good candidate for video inspection.
 FIELD_STRUCT_DESC: 14-inch steel stormdrain discharge pipe through the levee 2.5 feet below the crown. Pump on pile structure in drain ditch on landward side. Siphon breaker in 24-inch CMP riser on the waterward shoulder and flap gate on the waterward end (Permit No. 6537, 1969).
 FS Date: 09/10/2013

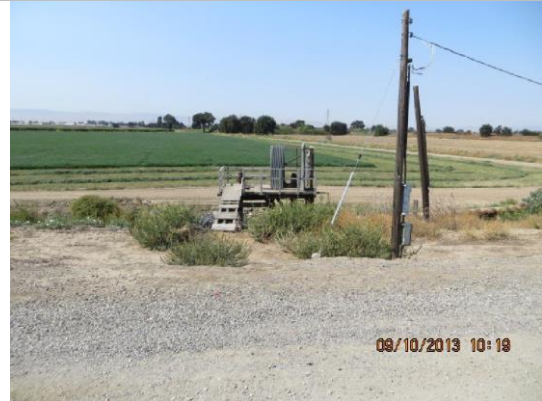
Photo 2 of 3 : UCIP_FA_2015_1683.jpg

Pump on wooden pier at LS toe.

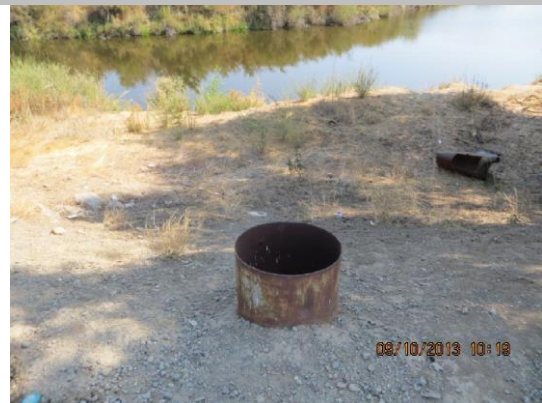
Photo 3 of 3 : UCIP_FA_2015_1684.jpg

Siphon Breaker/vent in 24-inch steel riser on WS shoulder.

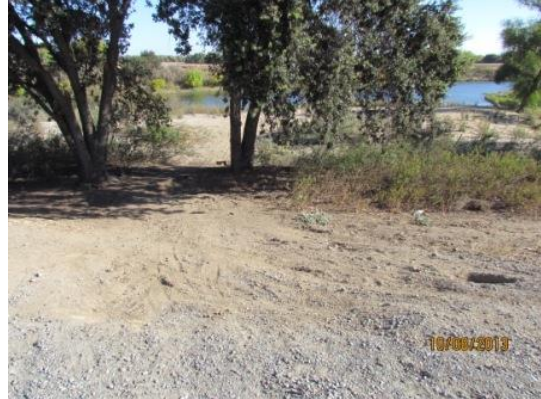
Photo 1 of 1 : FA_2015_RD2095_323_9_20150910_00006.jpg

LM Start	0.03	Rating **	A/W	Issue No.	9
LM End	0.03	Issue Type +	Ma	Location *	WS
Category	Earthen Levee			GPS Latitude/Longitude	
				Start	End
Item	Slope Stability			37.758986 °	37.758986 °
				-121.307854 °	-121.307854 °
DWR ID	DWR_RD2095_02_s_2013_9				
Action/Comments					
Repair the levee slope damaged by vehicle traffic and prevent access where possible.

View of the vehicle tire ruts on waterside levee slope.

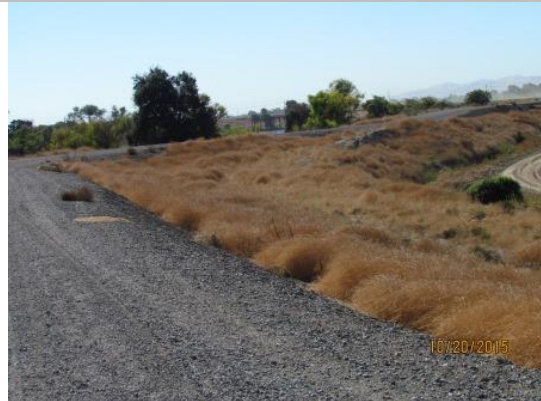
Photo 1 of 1 : FA_2015_RD2095_323_16_20151026_00014.jpg

LM Start	0.20	Rating **	A/W	Issue No.	16
LM End	0.34	Issue Type +	Ma	Location *	LS
Category	Earthen Levee			GPS Latitude/Longitude	
				Start	End
Item	Vegetation			37.757042 °	37.755242 °
				-121.306133 °	-121.305653 °
DWR ID	DWR_RD2095_02_f_2015_16				
Action/Comments					
Control annual grass and weeds on the levee slopes and easements. Inspector Comments: The LMA removed the vegetation from the landside levee slope.

View of the tall vegetation on the landside levee slope.

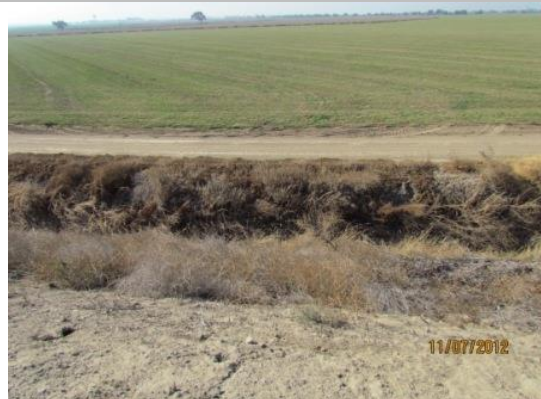
Photo 1 of 1 : FA_2015_RD2095_323_5_20150910_00004.jpg

LM Start	0.36	Rating **	M	Issue No.	5
LM End	0.82	Issue Type +	En	Location *	LS
Category	Earthen Levee			GPS Latitude/Longitude	
				Start	End
Item	Encroachments			37.754952 °	37.749645 °
				-121.305880 °	-121.301977 °
DWR ID	DWR_RD2095_02_f_2012_5				
Action/Comments					
Ditch

View of a ditch along the landside toe.

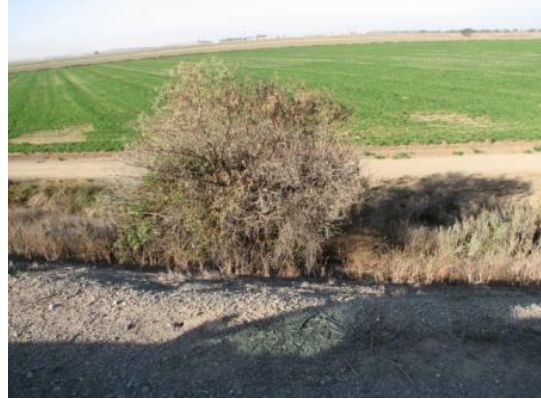
Photo 1 of 1 : FA_2015_RD2095_323_6_20150910_00005.jpg

11/01/2011 Elderberry bush at landside toe.

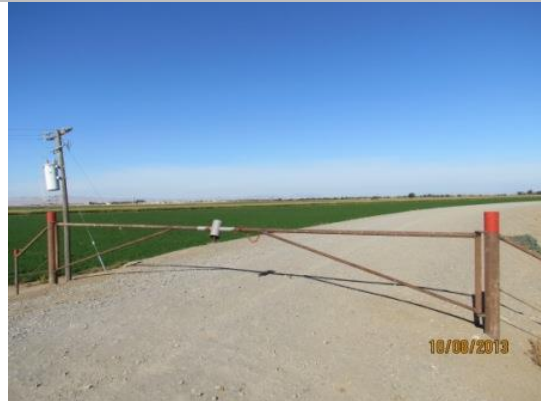
Photo 1 of 1 : FA_2015_RD2095_323_14_20150910_00007.jpg

LM Start	0.74	Rating **	A/W	Issue No.	14
LM End	0.74	Issue Type +	En	Location *	LS
Category	Earthen Levee			GPS Latitude/Longitude	
				Start	End
Item	Encroachments			37.749916 °	37.749916 °
				-121.303312 °	-121.303312 °
DWR ID	DWR_RD2095_02_f_2013_14				
Action/Comments					
Fence					
Inspector Comments: Permitted gate across levee crown. A key was provided to the DWR inspector.

View of new gate across levee crown.

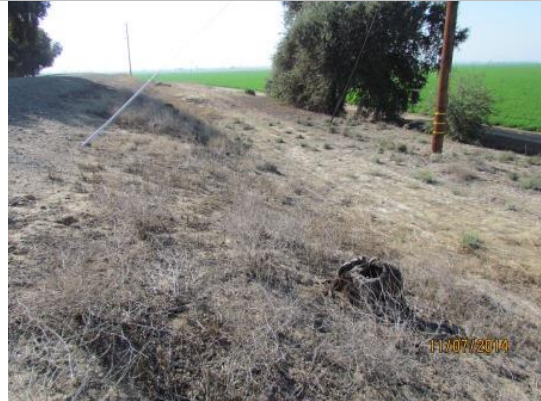
Photo 1 of 1 : FA_2015_RD2095_323_3_20150910_00003.jpg

View of the tree stumps on the landside levee slope..

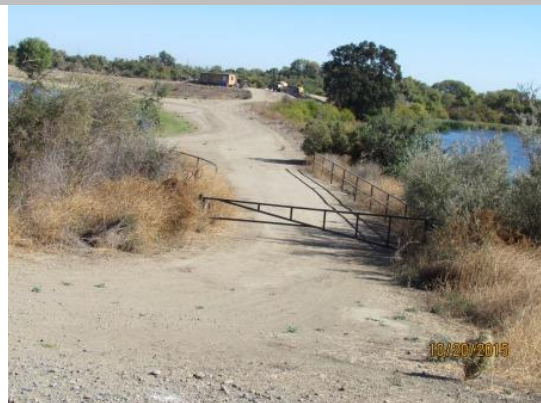
Photo 1 of 1 : FA_2015_RD2095_323_17_20151026_00015.jpg

View of the gate and fence in the floodway at the waterside levee toe.

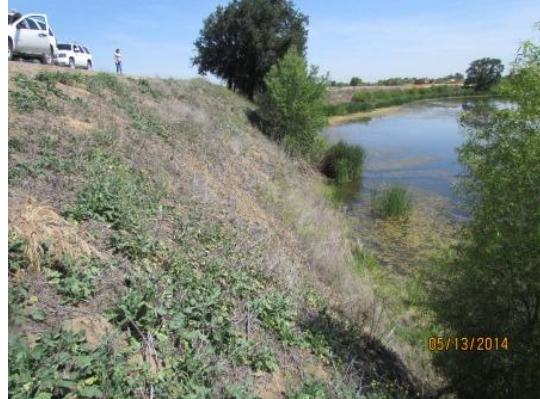
Photo 1 of 1 : FA_2015_RD2095_323_195_20150910_00009.jpg

View of the erosion on the waterside levee slope possibly eroding into the levee prism.

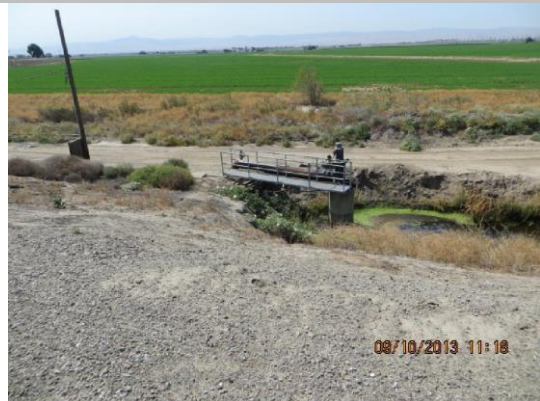
Photo 1 of 1 : UCIP_FA_2015_1768.jpg

LM Start	1.48	Rating **	M	Issue No.	942
LM End	1.48	Issue Type +	En	Location *	WS
Category	Supplemental			GPS Latitude/Longitude	
				Start	End
Item	DWR UCIP Field Study			37.743142 °	37.743142 °
				-121.297692 °	-121.297692 °
DWR ID					
Action/Comments					
Inspector Comments: FS_ID:19863 DS_ID:21642 EP_NO: 4658 FS_HLM: 1.5 Repair Type: Non-Urgent Crossing Status: Found UCIP Comments: Pipe appears abandoned in place and re-routed to LM 1.652. Need to verify pipe was properly abandoned. Permit FIELD_STRUCT_DESC: "Abandoned" 14-inch pipe through levee 3.5-feet below crown. Pump on structure over drain ditch on the landward side. Flap gate on the waterward end (Permit No. 4658). Originally included in the 1968 O&M manual. FS Date: 09/10/2013

Pump visible on LS toe, but pipe has been re-routed to southwest.

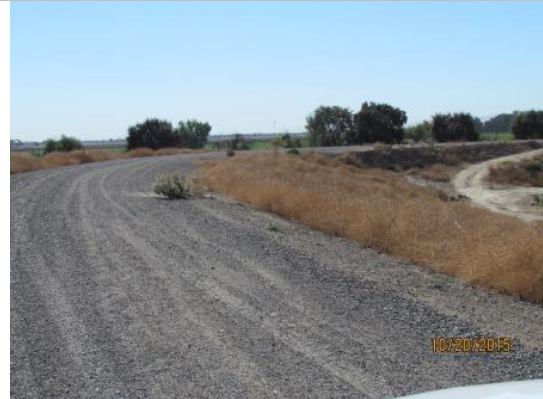
Photo 1 of 1 : FA_2015_RD2095_323_18_20151026_00016.jpg

View of the tall vegetation on the landside levee slope.

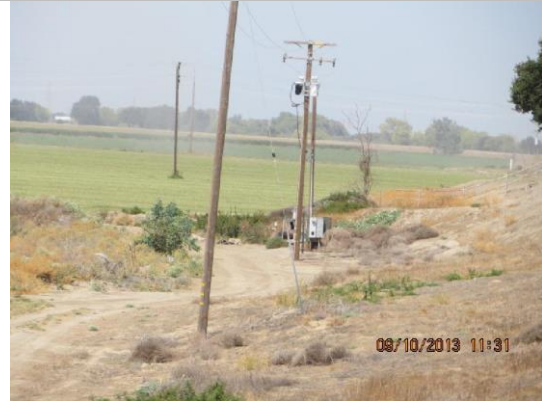
Photo 1 of 3 : UCIP_FA_2015_1769.jpg

Action/Comments					
Inspector Comments: FS_ID:19866 DS_ID:21654 EP_NO: 6298A FS_HLM: 1.653 Repair Type: Non-Urgent Crossing Status: Found UCIP Comments: No permit identified for this crossing. FIELD_STRUCT_DESC: 16-inch steel stormdrain pipe through the levee 2-feet below the crown. Siphon breaker in PVC riser on WS shoulder. Pump on pier in ditch on LS toe 750-feet to Northwest from crossing. FS Date: 09/10/2013

Pump located at levee toe 750-feet north west of pipe crossing.

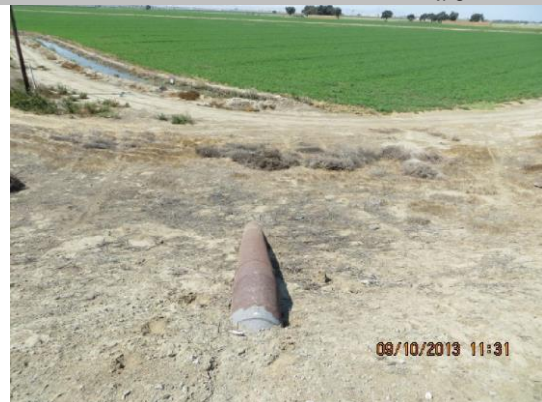
Photo 2 of 3 : UCIP_FA_2015_1770.jpg

16-inch steel pipe on LS slope.

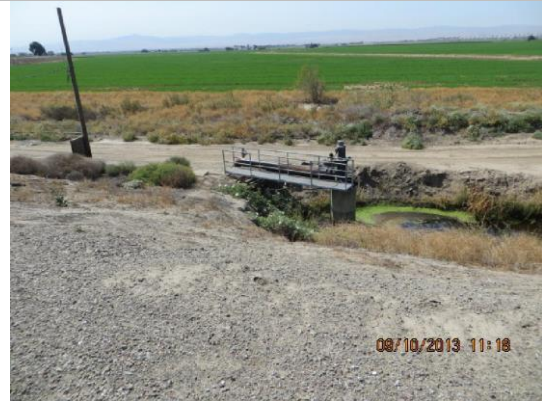
Photo 3 of 3 : UCIP_FA_2015_1771.jpg

Pump located at levee toe 750-feet north west of pipe crossing.

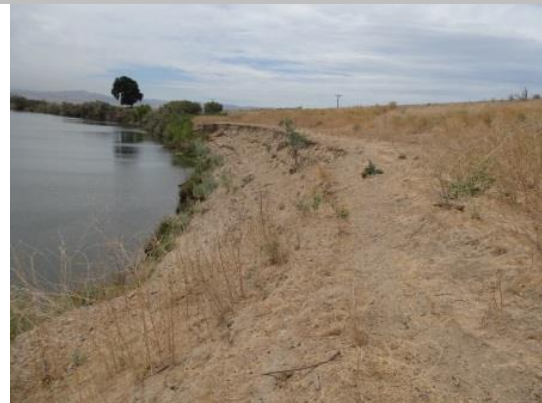
Photo 1 of 3 : SJR2015_RD2095U02RM60.62_12.jpg

LM Start	1.74	Rating **	M	Issue No.	1
LM End	1.77	Issue Type +	Ma	Location *	WS
Category	Supplemental			GPS Latitude/Longitude	
				Start	End
Item	DWR Erosion Survey			37.740196 °	37.740196 °
				-121.297662 °	-121.297662 °
DWR ID					
Action/Comments					
Inspector Comments: 08/04/2015: No significant change observed. 7/02/2014: No significant change observed. 08/28/2013: No significant change observed. 09/13/2012: The site has been visited by land survey. The vegetation on the site shows the erosion has not developed significantly from the last survey. The site was not visited by boat survey due to the limitation of navigable waterway. 08/23/2011: No significant change observed. 9/22/2010: No significant change observed. There is moderate vegetation growth on the berm. Despite the erosion occurring on the berm, corrective action should be taken before the issue becomes severe. 9/29/2009: Site is immediately downstream of a section of existing rip rap; there is a 20-foot berm remaining; berm will continue to erode unless erosion is mitigated; Site# is the same as RM62.6, LM1.87; recommended for annual assessment, per CES Evaluation 2008 Report 2006: Visited 10/20/06 [2015 Site ID:RD2095U02RM60.62]

Close view of the site.

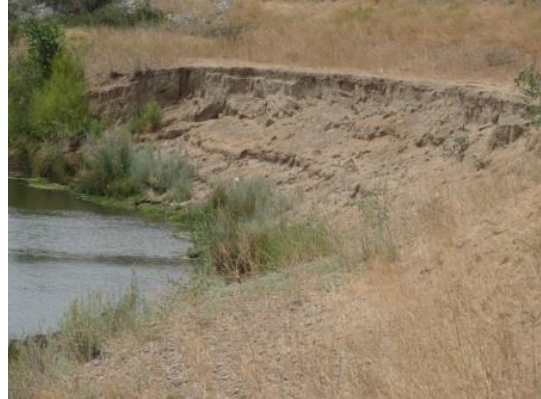
Photo 2 of 3 : SJR2015_RD2095U02RM60.62_13.jpg

Inspector Comments: 08/04/2015: No significant change observed.
 7/02/2014: No significant change observed.
 08/28/2013: No significant change observed.
 09/13/2012: The site has been visited by land survey. The vegetation on the site shows the erosion has not developed significantly from the last survey.
 The site was not visited by boat survey due to the limitation of navigable waterway.
 08/23/2011: No significant change observed.
 9/22/2010: No significant change observed. There is moderate vegetation growth on the berm. Despite the erosion occurring on the berm, corrective action should be taken before the issue becomes severe.
 9/29/2009: Site is immediately downstream of a section of existing rip rap; there is a 20-foot berm remaining; berm will continue to erode unless erosion is mitigated; Site# is the same as RM62.6, LM1.87; recommended for annual assessment, per CES Evaluation 2008 Report 2006: Visited 10/20/06 [2015 Site ID:RD2095U02RM60.62]

View of the erosion.

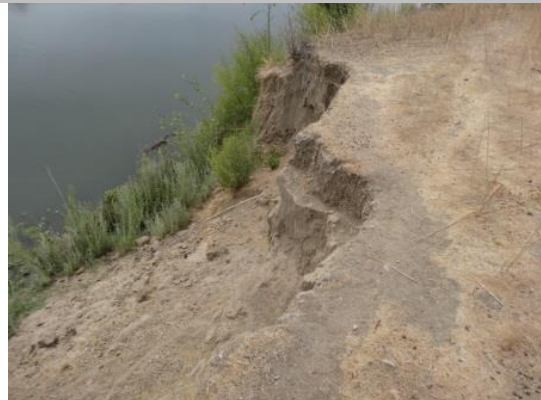
Photo 3 of 3 : SJR2015_RD2095U02RM60.62_4.jpg

Close view of the site.

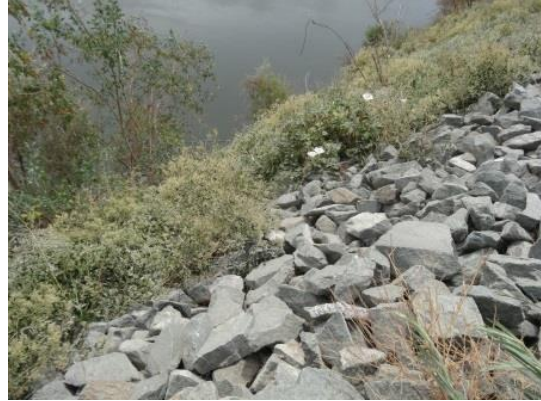
Photo 1 of 1 : SJR2015_RD2095U02RM60.69_2.jpg

LM Start	1.82	Rating **	M	Issue No.	2
LM End	1.86	Issue Type +	Ma	Location *	WS
Category	Supplemental			GPS Latitude/Longitude	
				Start	End
Item	DWR Erosion Survey			37.738880 °	37.738880 °
				-121.298260 °	-121.298260 °
DWR ID					
Action/Comments					
Inspector Comments: 08/04/2015: No significant change observed. 7/02/2014: No significant change observed. 08/28/2013: No significant change observed. Dense vegetation blocks the visual inspection at the site. 09/13/2012: The site has been visited by land survey. The erosion is not visible from the levee slope because of dense vegetation at the site.

The erosion is not visible from the levee top. The levee slope is protected by riprap rocks.

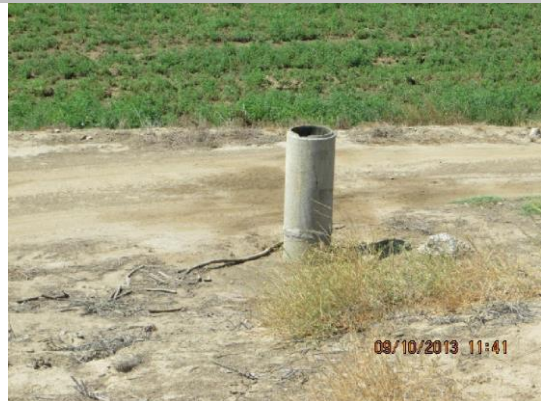
Photo 1 of 3 : UCIP_FA_2015_1772.jpg

LM Start	2.08	Rating **	M	Issue No.	944
LM End	2.08	Issue Type +	En	Location *	WS
Category	Supplemental			GPS Latitude/Longitude	
				Start	End
Item	DWR UCIP Field Study			37.735416 °	37.735416 °
				-121.297860 °	-121.297860 °
DWR ID					
Action/Comments					
Inspector Comments: FS_ID:19867 DS_ID:21643 EP_NO: N/A FS_HLM: 2.105 Repair Type: Non-Urgent Crossing Status: Found UCIP Comments: Siphon breaker on LS shoulder does not appear to be functional. FIELD_STRUCT_DESC: 16-inch steel irrigation pipe through the levee 2.0-feet below the crown. Slant pump on steel platform on WS slope. Siphon breaker on the landward shoulder marked by T-post. Service pole and meter on the landward toe. Possible concrete standpipe on LS toe. Originally included in the 1968 O&M manual. FS Date: 09/10/2013

Concrete standpipe on LS toe.

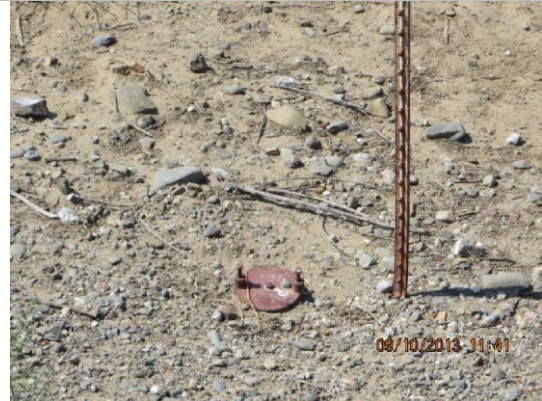
Photo 2 of 3 : UCIP_FA_2015_1773.jpg

Siphon breaker on LS shoulder next to T-post.

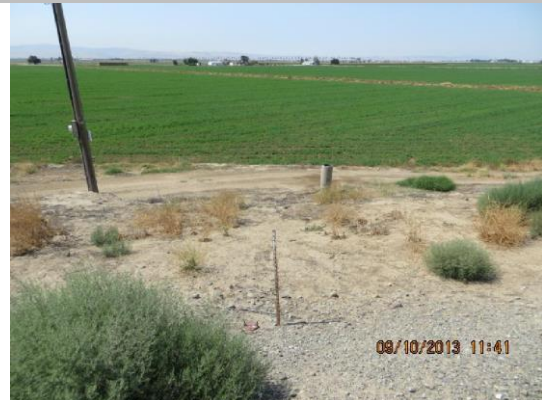
Photo 3 of 3 : UCIP_FA_2015_1774.jpg

Siphon breaker on LS shoulder next to T-post with Power pole and concrete standpipe on LS toe.
